Manhole Inspection Summary

Manhole # S13SS1010MH

Insp Date: **11/9/06 9:42 AM**

Location Address: **5123 SUNSET RD** Cross Street: **LEVINDALE RD**

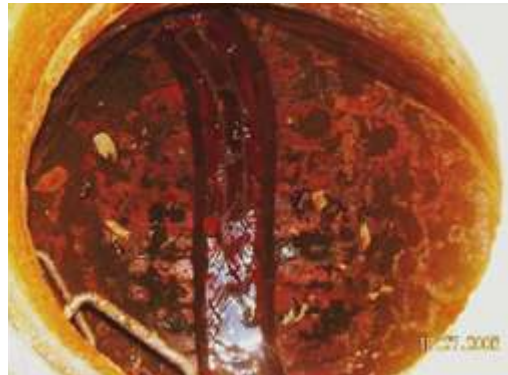
Top View

Bench debris.

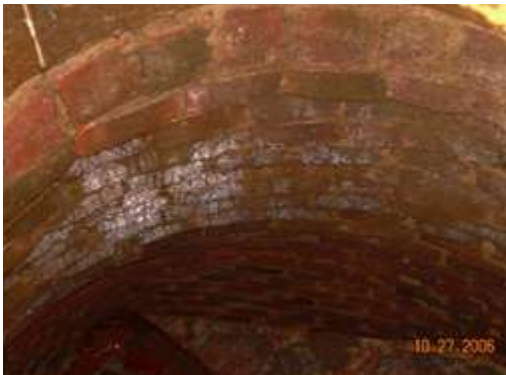
Defect

Frame Offset: **0** (in.) Condition: ☐ Sound ☐ Cracked ☒ **Leaks**

Infiltration: ☐ None ☒ **Joint** ☐ Cracks ☒ **Mortar** ☐ Roots ☐ Wall

Infiltration: ☐ None ☐ Joint ☐ Cracks ☒ **Mortar** ☐ Roots ☒ **Wall**

Frame leaks. Adjustment and Corbel infiltration.

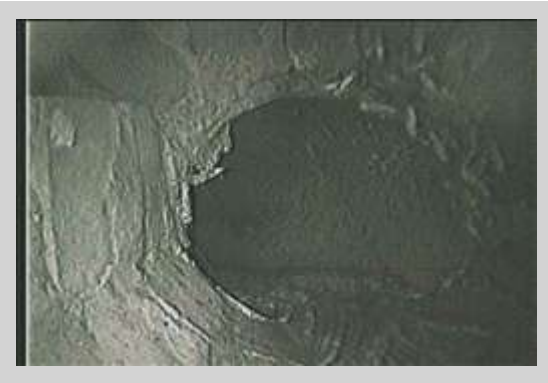
Pipe Out @ 12 O'Clock

Infiltration: **Evidence** Pipe Seal Cond: **Cracked**

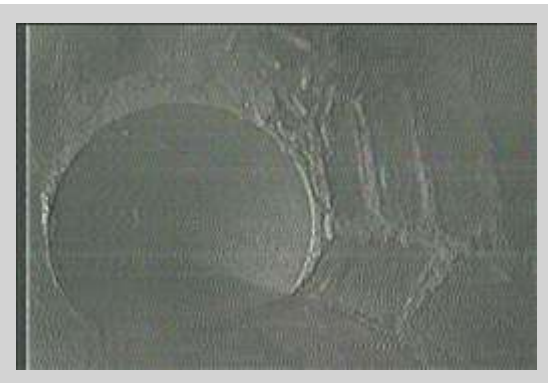
Pipe In @ 6 O'Clock

Infiltration: **Evidence** Pipe Seal Cond: **Cracked**
